UNITED STATES ENVIRONMENTAL PROTECTION AGENCY
REGION 5
77 WEST JACKSON BOULEVARD
CHICAGO, IL 60604

SUBJECT: INSPECTION REPORT – West Bay Exploration Co, Jackson County, Michigan.
Facility: Lantis 30 CPF, Napoleon Township

Date of Inspection: August 28, 2014

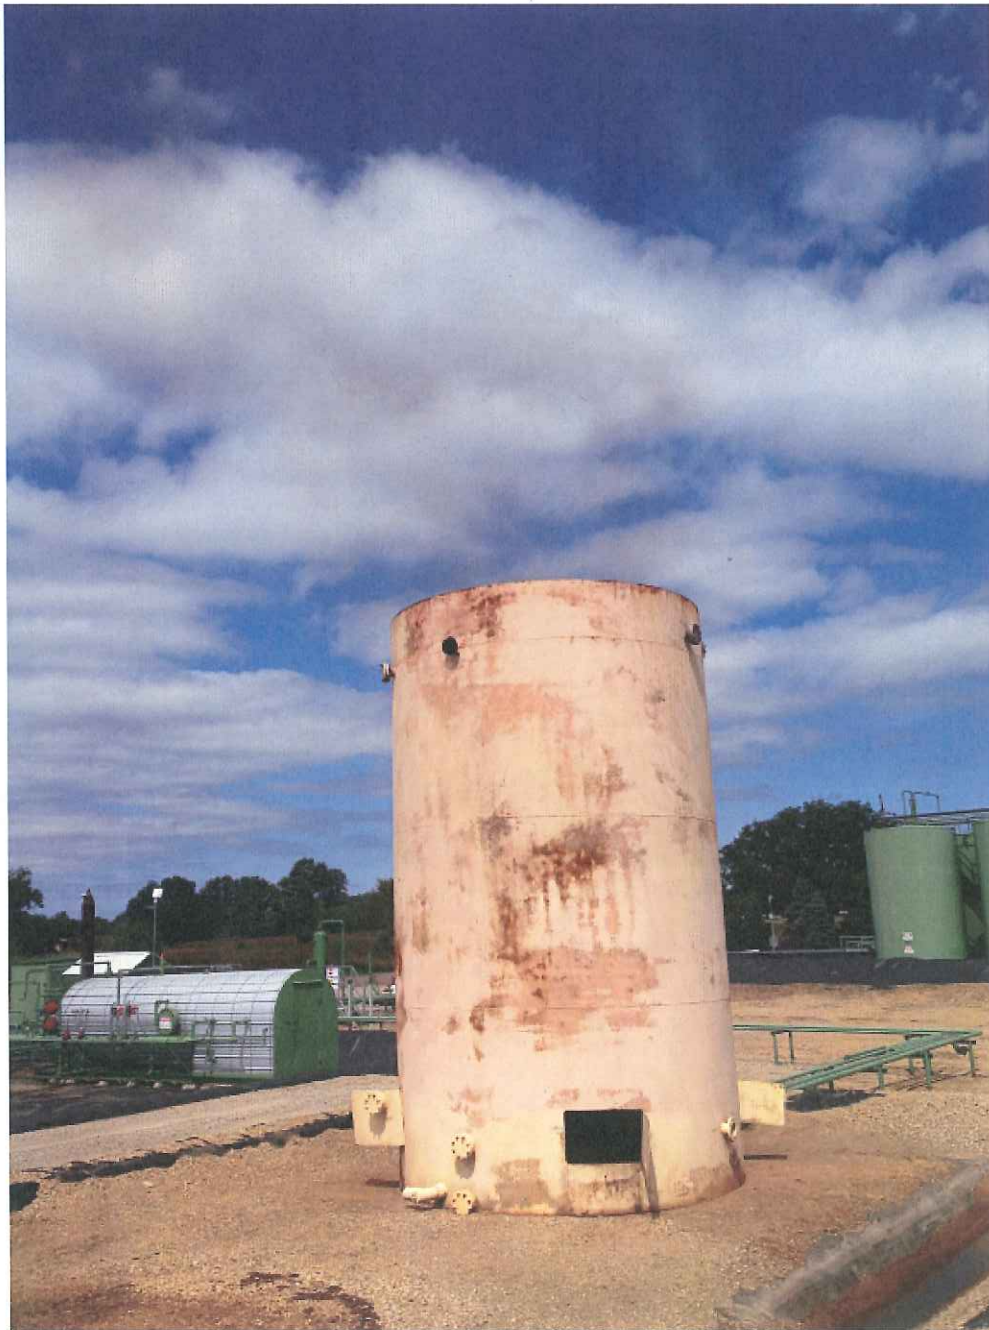
The visible emissions from the flare were present for the duration of my inspection.

I shared my observations with Mr. Baker and Mr. Pelham regarding which tank hatches were leaking. I also stated that I was concerned that the visible emissions from the flare indicated

1) Flare with visible emissions. Heater treaters at left; tank battery at right.

Mr. Baker stated that West Bay was considering installing a fan on the flare to draw vapors to the flare, and that a 9-to-1 ratio of air to hydrocarbons was necessary for good flare combustion. Mr. Baker stated that the company was also planning on routing vapors from the VRU to go directly to the flare, although he did not specify a timeframe for this action.

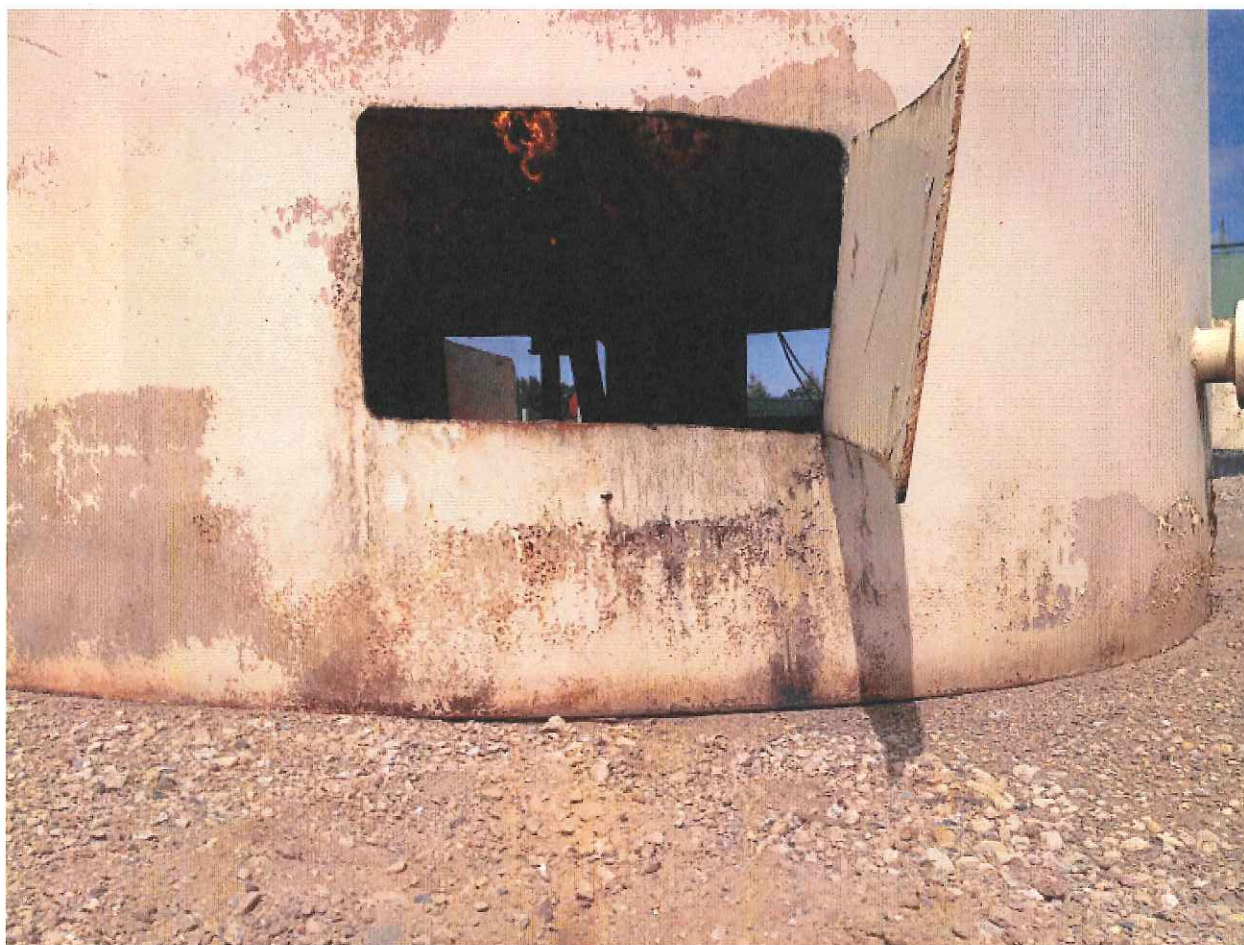
2) View inside flare shroud, showing lit flame.

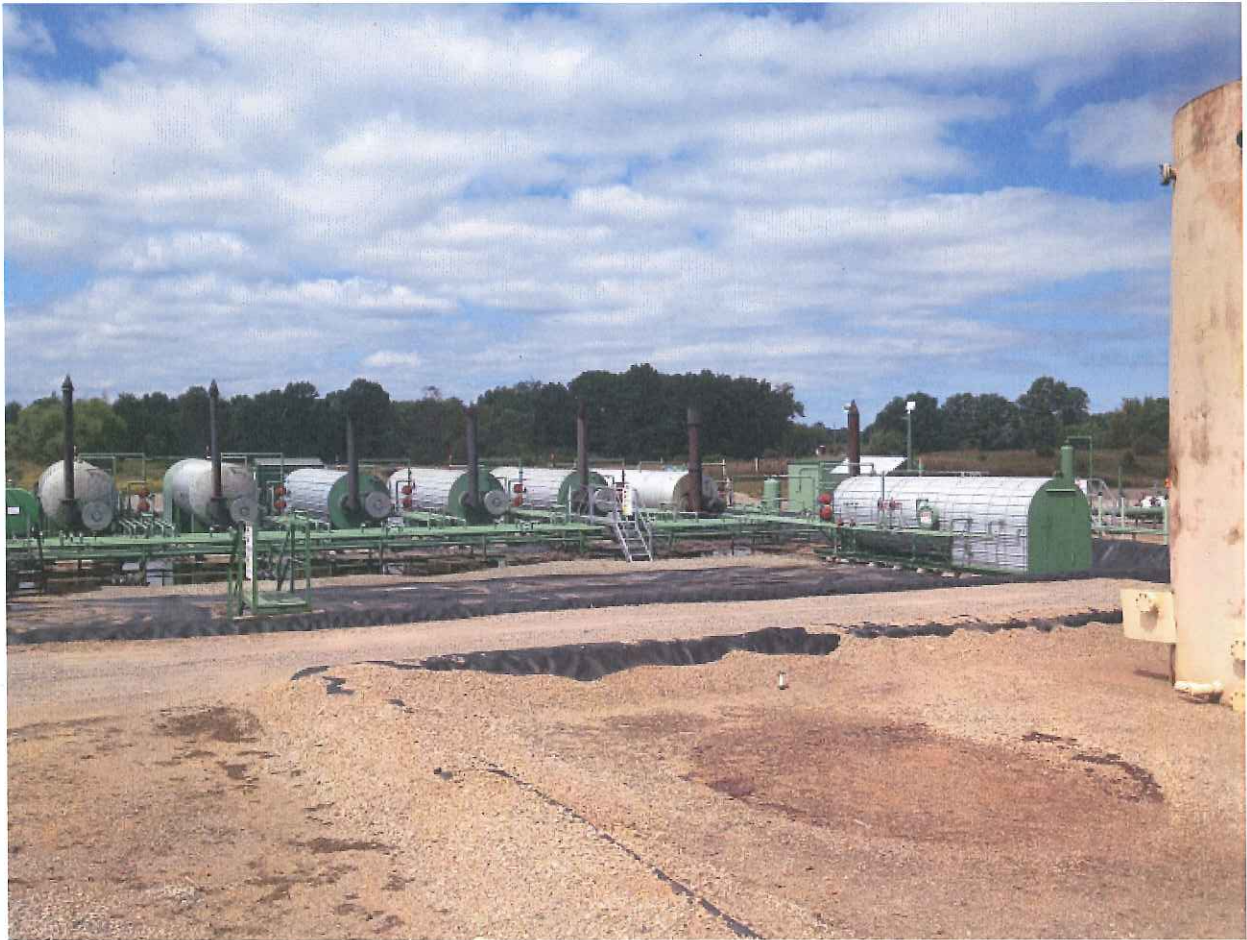
3) Heater treaters.

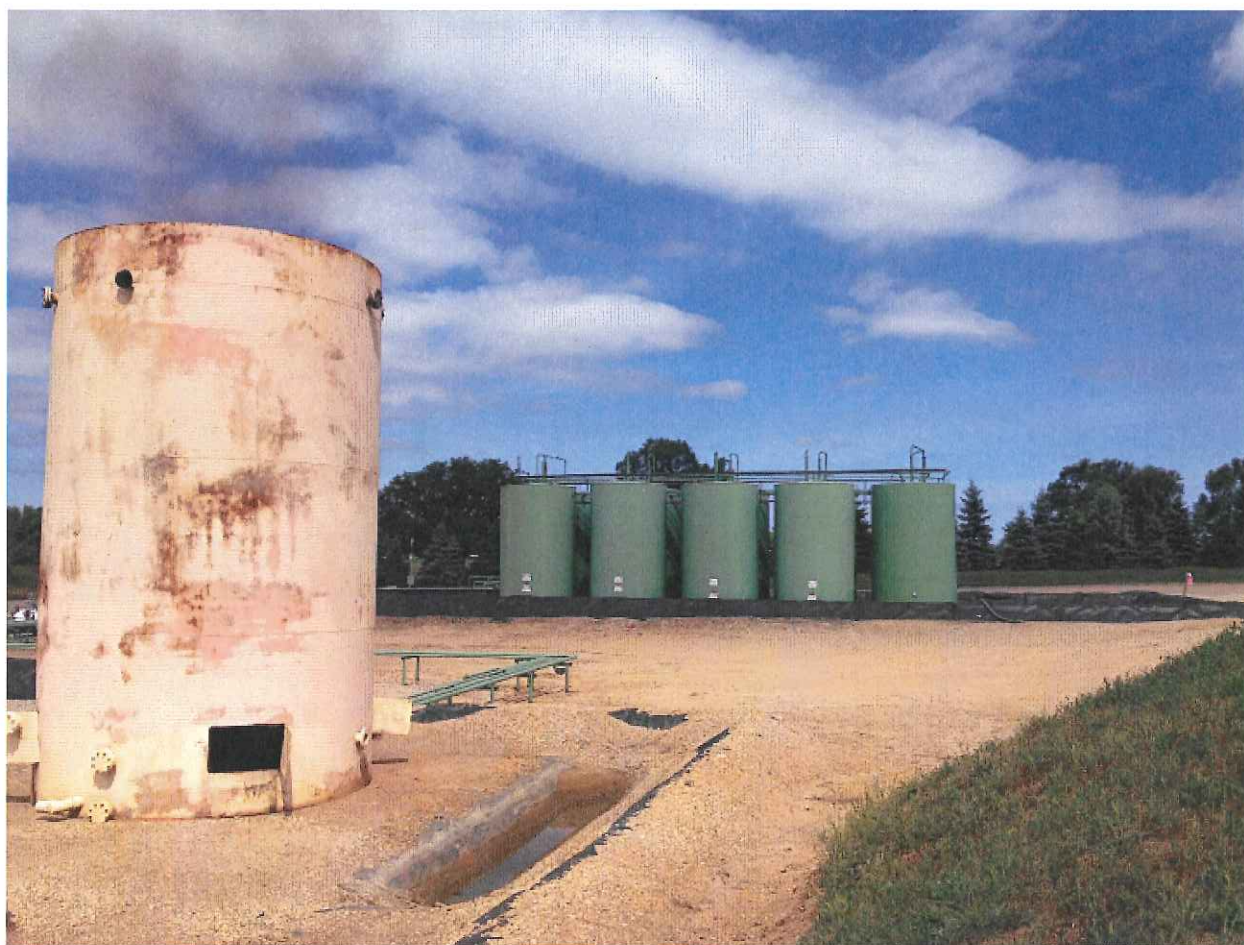
4) Tank battery, and flare showing visible emissions.

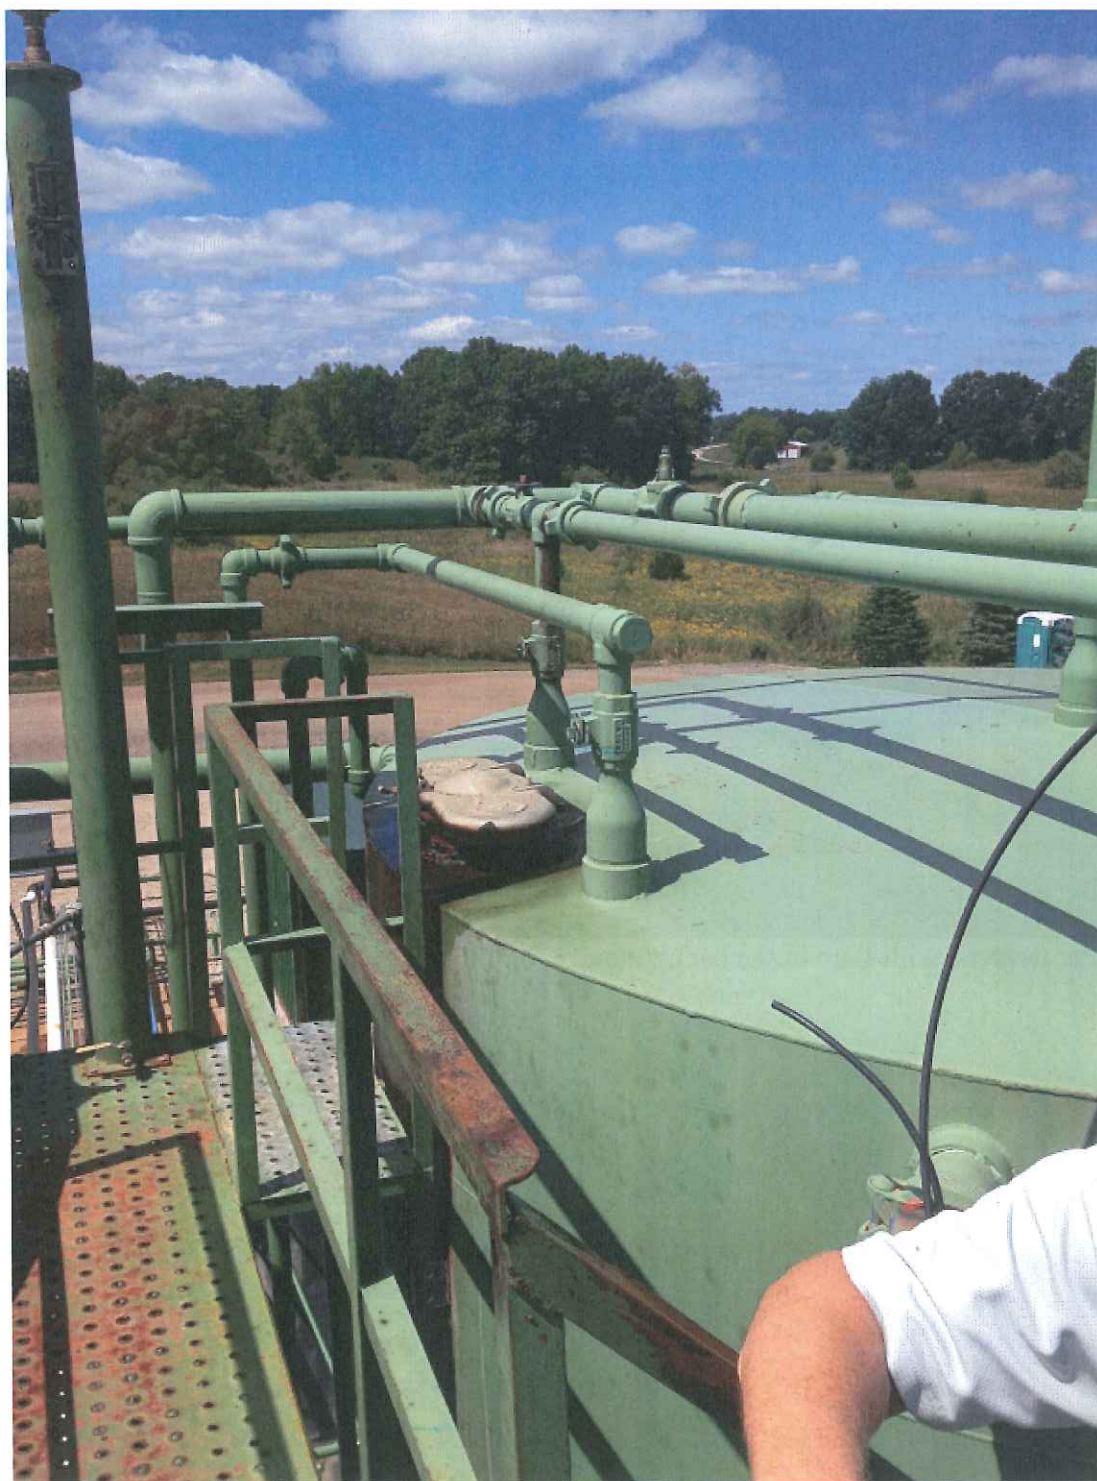
I took several photos of the flare and overall facility (see photos section). I climbed the stairway of the tank battery and viewed each of the thief hatches with and without the IR camera (a FLIR GF320). At least two of the hatches were audibly hissing, and emissions from the hatches were causing visible refraction of the air around the hatch. The petroleum odor was also quite strong along the walkway. The IR camera showed all the thief hatches leaking continuously (see IR Video Log and diagram). The truck that had been loading earlier had departed the facility by this point.

I pointed out my observations to Mr. Baker and Mr. Grewe. Both Mr. Baker and Mr. Grewe stated that the leaking hatches were out of the ordinary. They speculated that a dump valve at one of the heater treaters was stuck open, causing continuous flow into the tank and excess volatilization of material in the tanks. The West Bay representatives immediately went to investigate. It was confirmed that a water dump valve was indeed stuck open. Mr. Pelham stated that the individual water dump had been shut off until the stuck valve could be fixed. However, during the period of my observations, the hatches continued to leak.

Mr. Grewe stated that the weights of the springs on the thief hatches were six ounces, meaning that pressure would be relieved from the hatches if it exceeded six ounces per square inch (oz/in²). I asked Mr. Baker if West Bay owned an IR camera. He stated that West Bay did not, but that it had a third party conduct an IR survey once per year. I asked what kind of procedures were in place to monitor the facility's equipment to ensure it was operating properly. Mr. Baker stated that the heater treater flows were monitored remotely, and that there was remote gauging on the tanks as well. He stated that when the lease operators report their numbers (such as the quantities of oil or brine removed from the tanks for transport), it was company policy that the operators also ensure that all equipment was in working order.

5) Example of thief hatch at top of tank.

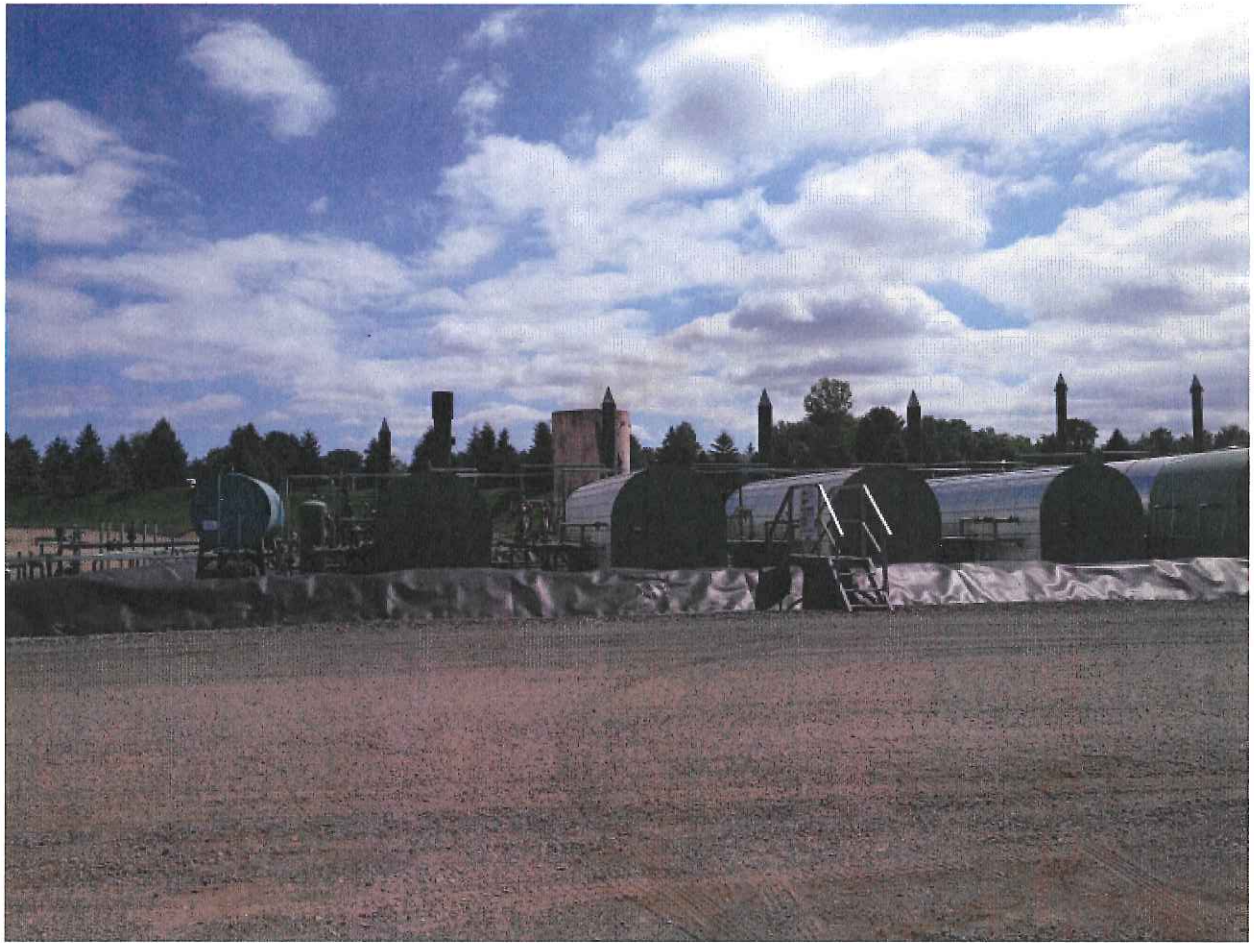
6) Heater treaters, with flare in the background.
